**Flood Control Project Maintenance
Levee Inspections**

Fall 2015 Levee Maintenance Deficiency Summary Report

Sacramento River Basin

Sutter Maintenance Yard East Levee Sutter Bypass

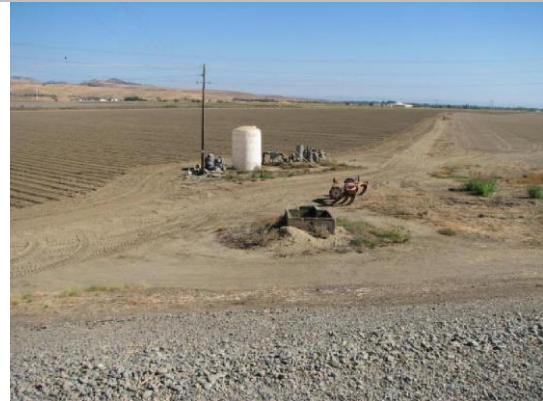
Photo 1 of 3 : UCIP_FA_2015_4864.jpg

Action/Comments					
Inspector Comments: FS_ID:45050 DS_ID:16862 EP_NO: 10932 FS_HLM: 1.134 Repair Type: Non-Urgent Crossing Status: Found UCIP Comments: 5/7/2015 24in. cmp riser and siphon breaker were not found on the WS shoulder. Pier has no walkway to access pump on pier. This is not necessarily an issue. 5/22/2013 24in. cmp riser on WS shoulder is full of garbage and dirt and should be cleaned out to inspect siphon breaker. 10/30/2013 24in. cmp riser was pulled out of levee and there is no sign of a siphon breaker on WS shoulder. 5/13/2014 Same as last inspection. 11/12/2014 Same as last inspection. FIELD_STRUCT_DESC: 16-inch steel pipe through the levee, 6.3 feet below the crown. Vertical pump mounted on a steel structure on the bank. Siphon breaker in a 24-inch corrugated metal pipe riser on the waterward slope. Concrete distribution box on the landward side. JP on WS shoulder. Original Equipment in O+M. Replaced under (App. 10932-Nall) Hand drawings available in permit. FS Date: 05/11/2015

7'X7' concrete distribution box on LS toe.

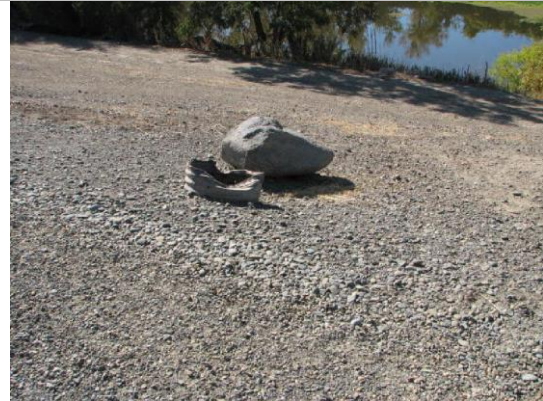
Photo 2 of 3 : UCIP_FA_2015_4865.jpg

Action/Comments					
Inspector Comments: FS_ID:45050 DS_ID:16862 EP_NO: 10932 FS_HLM: 1.134 Repair Type: Non-Urgent Crossing Status: Found UCIP Comments: 5/7/2015 24in. cmp riser and siphon breaker were not found on the WS shoulder. Pier has no walkway to access pump on pier. This is not necessarily an issue. 5/22/2013 24in. cmp riser on WS shoulder is full of garbage and dirt and should be cleaned out to inspect siphon breaker. 10/30/2013 24in. cmp riser was pulled out of levee and there is no sign of a siphon breaker on WS shoulder. 5/13/2014 Same as last inspection. 11/12/2014 Same as last inspection. FIELD_STRUCT_DESC: 16-inch steel pipe through the levee, 6.3 feet below the crown. Vertical pump mounted on a steel structure on the bank. Siphon breaker in a 24-inch corrugated metal pipe riser on the waterward slope. Concrete distribution box on the landward side. JP on WS shoulder. Original Equipment in O+M. Replaced under (App. 10932-Nall) Hand drawings available in permit. FS Date: 05/11/2015

24-inch CMP riser on WS slope.

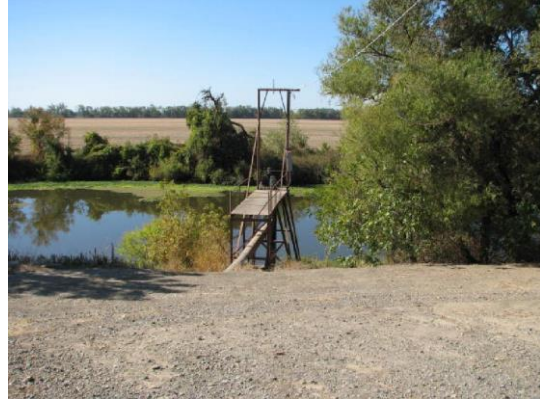
Photo 3 of 3 : UCIP_FA_2015_4866.jpg

UCIP Comments: 5/7/2015 24in. cmp riser and siphon breaker were not found on the WS shoulder. Pier has no walkway to access pump on pier. This is not necessarily an issue. 5/22/2013 24in. cmp riser on WS shoulder is full of garbage and dirt and should be cleaned out to inspect siphon breaker. 10/30/2013 24in. cmp riser was pulled out of levee and there is no sign of a siphon breaker on WS shoulder. 5/13/2014 Same as last inspection. 11/12/2014 Same as last inspection.

FIELD_STRUCT_DESC: 16-inch steel pipe through the levee, 6.3 feet below the crown. Vertical pump mounted on a steel structure on the bank. Siphon breaker in a 24-inch corrugated metal pipe riser on the waterward slope. Concrete distribution box on the landward side. JP on WS shoulder. Original Equipment in O+M. Replaced under (App. 10932-Nall) Hand drawings available in permit.

Pump on metal pier on WS slope.

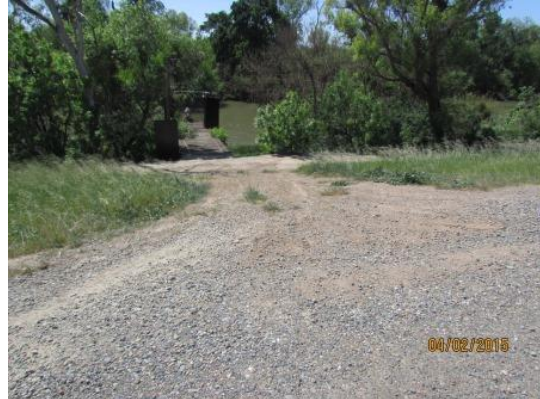
Photo 1 of 1 : FA_2015_ST0002_450_25_20150910_00004.jpg

LM Start	5.20	Rating **	M	Issue No.	25
LM End	5.20	Issue Type +	Ma	Location *	WS
Category	Earthen Levee			GPS Latitude/Longitude	
				Start	End
Item	Slope Stability			39.103313 °	39.103313 °
				-121.758813 °	-121.758813 °
DWR ID	DWR_ST0002_01_s _ 2015_25				
Action/Comments					
Repair the levee slope damaged by vehicle traffic and prevent access where possible. Inspector Comments: Repair the vehicle erosion along the waterside slope.

View of the vehicle erosion along the waterside slope.

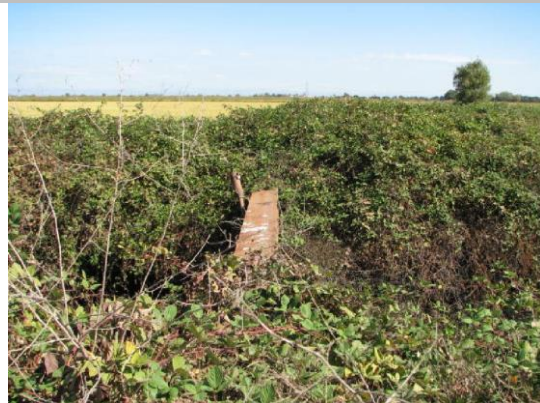
Photo 1 of 3 : UCIP_FA_2015_5013.jpg

LM Start	6.09	Rating **	M	Issue No.	33
LM End	6.09	Issue Type +	En	Location *	WS
Category	Supplemental			GPS Latitude/Longitude	
				Start	End
Item	DWR UCIP Field Study			39.091260 °	39.091260 °
				-121.752874 °	-121.752874 °
DWR ID					
Action/Comments					
Inspector Comments: FS_ID:45068 DS_ID:19983 EP_NO: N/A FS_HLM: 6.188 Repair Type: Non-Urgent Crossing Status: Found UCIP Comments: 5/7/2015 Crossing is in good condition. No noticeable issues to report.No permit or purpose identified for this crossing.5/22/2013 Same as last inspection.10/30/2013 Same as last inspection.5/13/2014 Same as last inspection.11/12/2014 Same as last inspection. FIELD_STRUCT_DESC: 2.5-inch steel pipe bored under the levee at unkn own depth. Pipe has locked cap on both LS and WS toe. Steel stairs on WS slope and steel I-beam stream crossing on LS toe mark location of pipe. FS Date: 05/11/2015

Capped pipe on LS toe on east side of ditch.

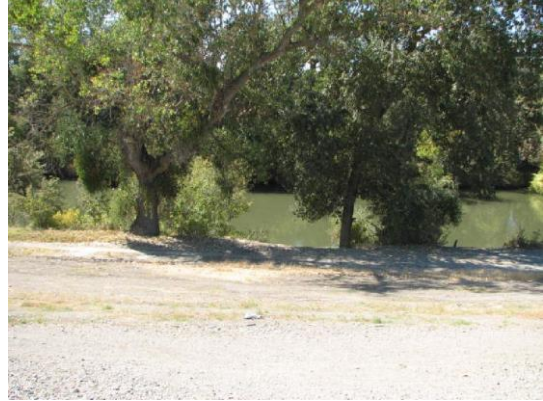
Photo 2 of 3 : UCIP_FA_2015_5014.jpg

LM Start	6.09	Rating **	M	Issue No.	33 (cont)
LM End	6.09	Issue Type +	En	Location *	WS
Category	Supplemental			GPS Latitude/Longitude	
				Start	End
Item	DWR UCIP Field Study			39.091260 °	39.091260 °
				-121.752874 °	-121.752874 °
DWR ID					
Action/Comments					
Inspector Comments: FS_ID:45068 DS_ID:19983 EP_NO: N/A FS_HLM: 6.188 Repair Type: Non-Urgent Crossing Status: Found UCIP Comments: 5/7/2015 Crossing is in good condition. No noticeable issues to report.No permit or purpose identified for this crossing.5/22/2013 Same as last inspection.10/30/2013 Same as last inspection.5/13/2014 Same as last inspection.11/12/2014 Same as last inspection. FIELD_STRUCT_DESC: 2.5-inch steel pipe bored under the levee at unkn own depth. Pipe has locked cap on both LS and WS toe. Steel stairs on WS slope and steel I-beam stream crossing on LS toe mark location of pipe. FS Date: 05/11/2015

Pipe between two trees on WS toe.

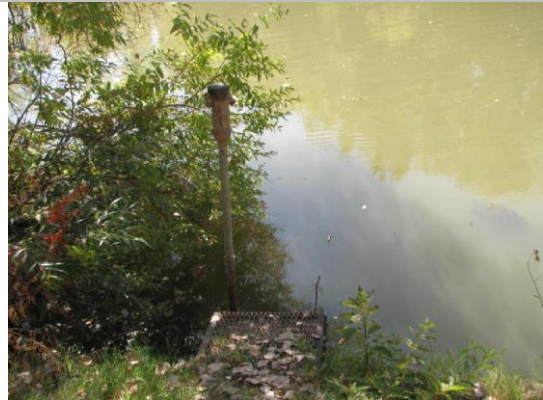
Photo 3 of 3 : UCIP_FA_2015_5015.jpg

Capped pipe and metal stairs on WS toe.

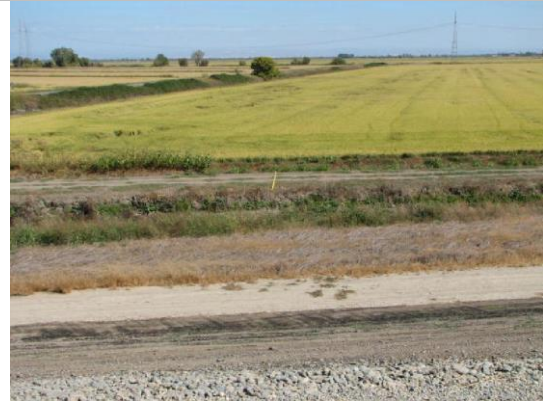
Photo 1 of 2 : UCIP_FA_2015_5044.jpg

LM Start	7.47	Rating **	M	Issue No.	34
LM End	7.47	Issue Type +	En	Location *	WS
Category	Supplemental			GPS Latitude/Longitude	
				Start	End
Item	DWR UCIP Field Study			39.072292 °	39.072292 °
				-121.744907 °	-121.744907 °
DWR ID					
Action/Comments					
Inspector Comments: FS_ID:45072					
DS_ID:19985					
EP_NO: N/A					
FS_HLM: 7.586					
Repair Type: Non-Urgent					
Crossing Status: Found

Gasline marker on LS toe east of ditch.

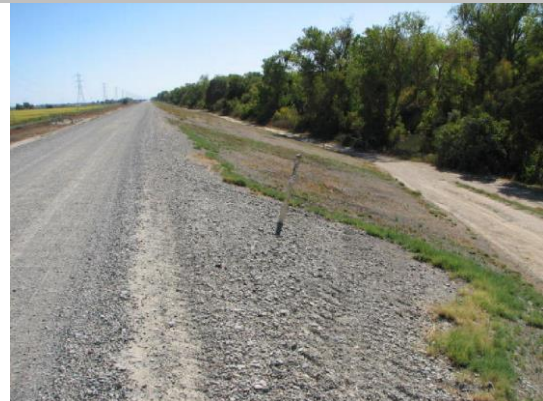
Photo 2 of 2 : UCIP_FA_2015_5045.jpg

Gasline marker on WS shoulder.

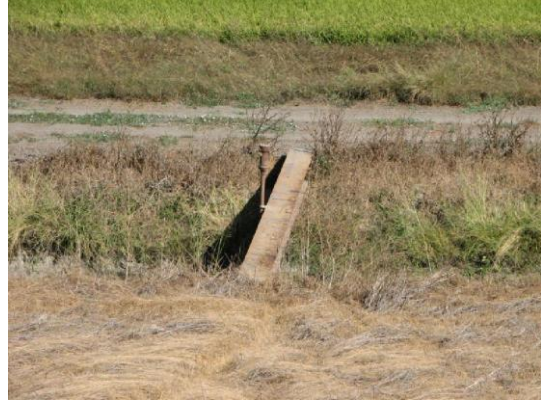
Photo 1 of 2 : UCIP_FA_2015_5046.jpg

LM Start	8.14	Rating **	M	Issue No.	35
LM End	8.14	Issue Type +	En	Location *	WS
Category	Supplemental			GPS Latitude/Longitude	
				Start	End
Item	DWR UCIP Field Study			39.062976 °	39.062976 °
				-121.741027 °	-121.741027 °
DWR ID					
Action/Comments					
Inspector Comments: FS_ID:45073					
DS_ID:19984					
EP_NO: N/A					
FS_HLM: 8.273					
Repair Type: Non-Urgent					
Crossing Status: Found

Pipe at steel i-beam crossing in ditch at LS toe.

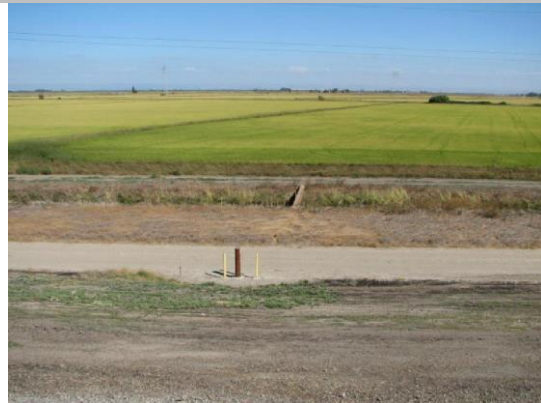
Photo 2 of 2 : UCIP_FA_2015_5047.jpg

Pipe at steel i-beam crossing in ditch at LS toe.

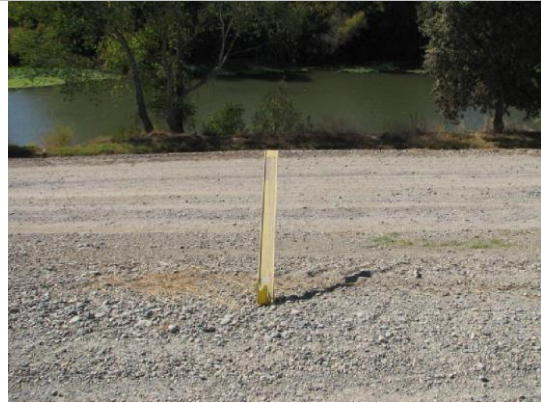
Photo 1 of 2 : UCIP_FA_2015_5048.jpg

LM Start	10.27	Rating **	M	Issue No.	36
LM End	10.27	Issue Type +	En	Location *	WS
Category	Supplemental			GPS Latitude/Longitude	
				Start	End
Item	DWR UCIP Field Study			39.033522 °	39.033522 °
				-121.728927 °	-121.728927 °
DWR ID					
Action/Comments					
Inspector Comments: FS_ID:45075					
DS_ID:16884					
EP_NO: 14455					
FS_HLM: 10.44					
Repair Type: Non-Urgent					
Crossing Status: Indicator Found

Gasline markers on WS shoulder.

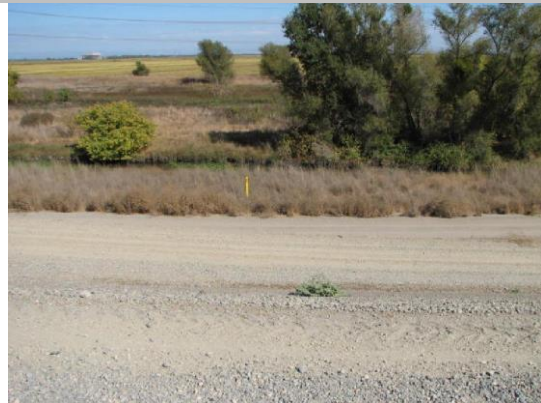
Photo 2 of 2 : UCIP_FA_2015_5049.jpg

Gasline markers on LS toe .

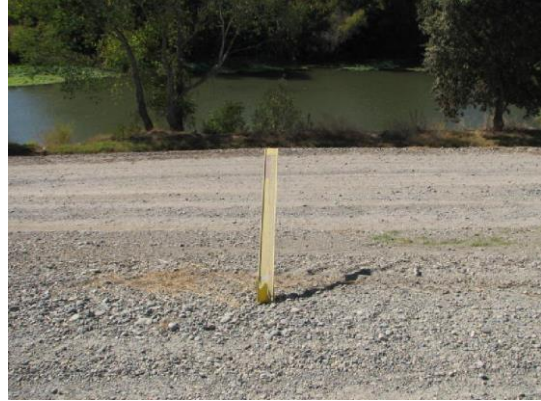
Photo 1 of 2 : UCIP_FA_2015_5050.jpg

LM Start	10.27	Rating **	M	Issue No.	37
LM End	10.27	Issue Type +	En	Location *	WS
Category	Supplemental			GPS Latitude/Longitude	
				Start	End
Item	DWR UCIP Field Study			39.033519 °	39.033519
				-121.728926 °	-121.728926
DWR ID					
Action/Comments					
Inspector Comments: FS_ID:45076					
DS_ID:16899					
EP_NO: 14455					
FS_HLM: 10.44					
Repair Type: Non-Urgent					
Crossing Status: Indicator Found

Gasline markers on WS shoulder.

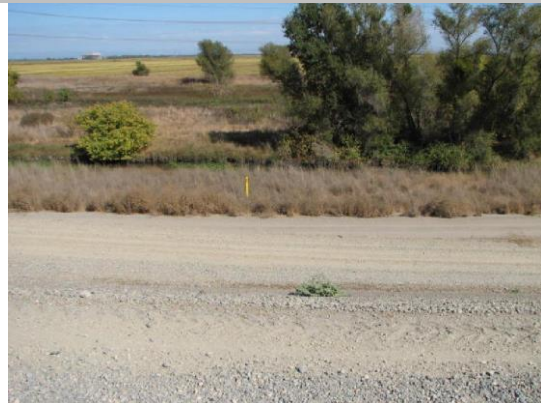
Photo 2 of 2 : UCIP_FA_2015_5051.jpg

Gasline markers on LS toe.

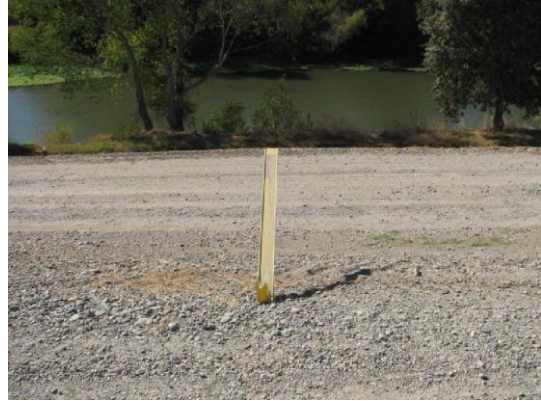
Photo 1 of 2 : UCIP_FA_2015_5180.jpg

LM Start	10.27	Rating **	M	Issue No.	38
LM End	10.27	Issue Type +	En	Location *	WS
Category	Supplemental			GPS Latitude/Longitude	
				Start	End
Item	DWR UCIP Field Study			39.033517 °	39.033517 °
				-121.728925 °	-121.728925 °
DWR ID					
Action/Comments					
Inspector Comments: FS_ID:45077					
DS_ID:16900					
EP_NO: 14455					
FS_HLM: 10.44					
Repair Type: Non-Urgent					
Crossing Status: Indicator Found

Gasline markers on WS shoulder.

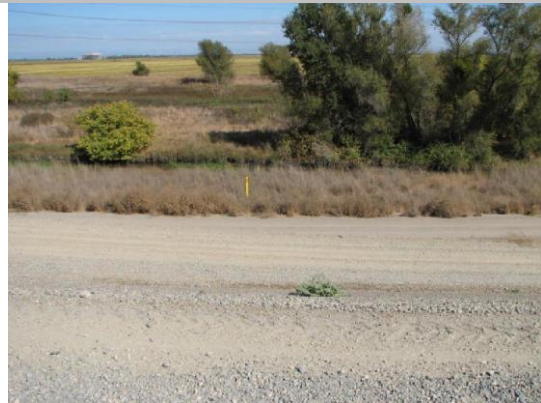
Photo 2 of 2 : UCIP_FA_2015_5181.jpg

Gasline markers on LS toe.

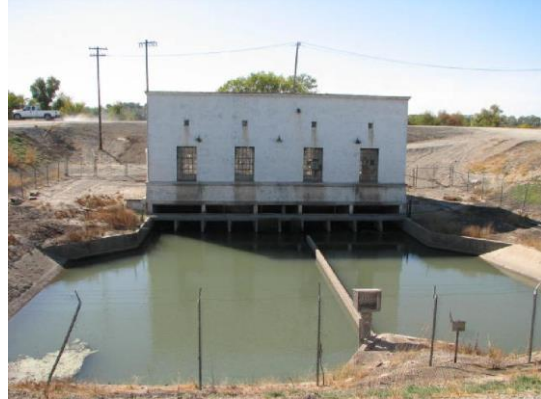
Photo 1 of 3 : UCIP_FA_2015_5182.jpg

LM Start	10.83	Rating **	M	Issue No.	39
LM End	10.83	Issue Type +	En	Location *	WS
Category	Supplemental			GPS Latitude/Longitude	
				Start	End
Item	DWR UCIP Field Study			39.025693 °	39.025693
				-121.726895 °	-121.726895
DWR ID					
Action/Comments					
Inspector Comments: FS_ID:45084					
DS_ID:16871					
EP_NO: N/A					
FS_HLM: 10.999					
Repair Type: Non-Urgent					
Crossing Status: Found

Pumphouse/intake structure on LS toe.

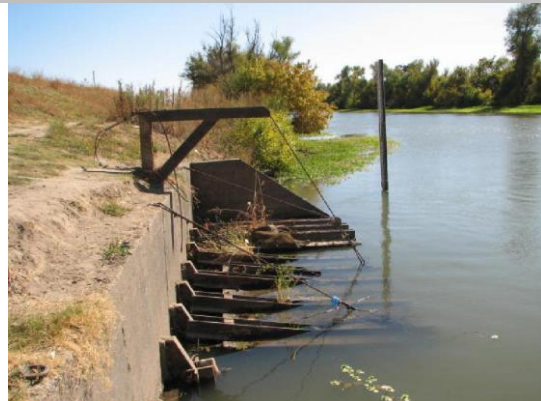
Photo 2 of 3 : UCIP_FA_2015_5183.jpg

Flap gates on WS toe.

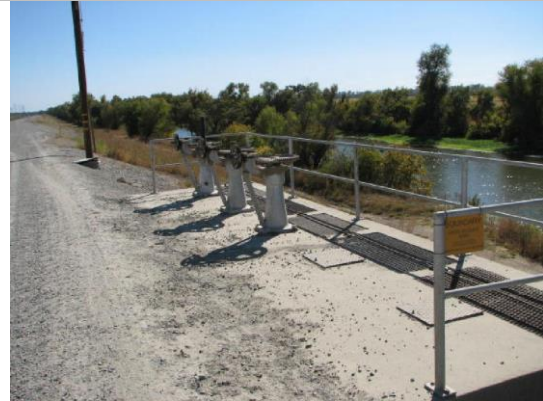
Photo 3 of 3 : UCIP_FA_2015_5184.jpg

LM Start	10.83	Rating **	M	Issue No.	39 (cont)
LM End	10.83	Issue Type +	En	Location *	WS
Category	Supplemental			GPS Latitude/Longitude	
				Start	End
Item	DWR UCIP Field Study			39.025693 °	39.025693
				-121.726895 °	-121.726895
DWR ID					
Action/Comments					
Inspector Comments: FS_ID:45084					
DS_ID:16871					
EP_NO: N/A					
FS_HLM: 10.999					
Repair Type: Non-Urgent					
Crossing Status: Found

Slide gates on WS shoulder

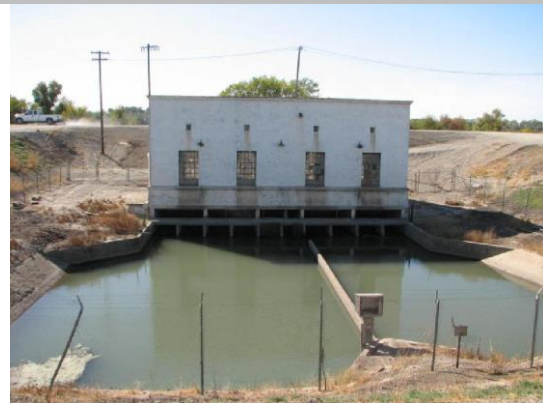
Photo 1 of 3 : UCIP_FA_2015_5185.jpg

LM Start	10.83	Rating **	M	Issue No.	40
LM End	10.83	Issue Type +	En	Location *	WS
Category	Supplemental			GPS Latitude/Longitude	
				Start	End
Item	DWR UCIP Field Study			39.025683 °	39.025683 °
				-121.726886 °	-121.726886 °
DWR ID					
Action/Comments					
Inspector Comments: FS_ID:45085 DS_ID:16906 EP_NO: N/A FS_HLM: 10.999 Repair Type: Non-Urgent Crossing Status: Found UCIP Comments: 5/7/2015 Abandoned crossing but no noticeable issues to report.Determine type of abandonment.5/22/2013 Same as last inspection.10/30/2013 Same as last inspection.5/13/2014 Same as last inspection.11/12/2014 Same as last inspection. FIELD_STRUCT_DESC: 2 of 5. 4-foot by 6-foot concrete box culvert through the levee, 31.5 feet below the crown. Wood flap gate and concrete headwall on the waterward end. Wooden steps on the landward slope. Concrete steps on the waterward end. Originally included in the O+M Manual. FS Date: 05/11/2015

Pumping plant on LS toe.

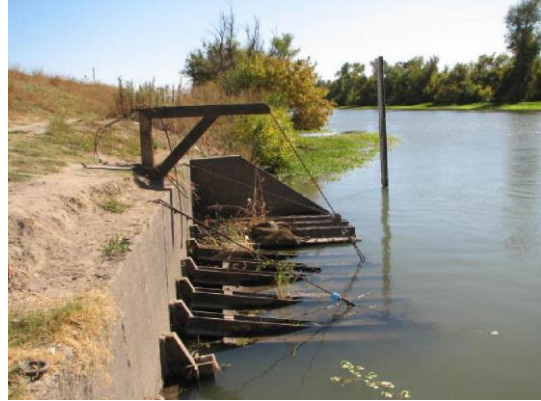
Photo 2 of 3 : UCIP_FA_2015_5186.jpg

LM Start	10.83	Rating **	M	Issue No.	40 (cont)
LM End	10.83	Issue Type +	En	Location *	WS
Category	Supplemental			GPS Latitude/Longitude	
				Start	End
Item	DWR UCIP Field Study			39.025683 °	39.025683 °
				-121.726886 °	-121.726886 °
DWR ID					
Action/Comments					
Inspector Comments: FS_ID:45085 DS_ID:16906 EP_NO: N/A FS_HLM: 10.999 Repair Type: Non-Urgent Crossing Status: Found UCIP Comments: 5/7/2015 Abandoned crossing but no noticeable issues to report.Determine type of abandonment.5/22/2013 Same as last inspection.10/30/2013 Same as last inspection.5/13/2014 Same as last inspection.11/12/2014 Same as last inspection. FIELD_STRUCT_DESC: 2 of 5. 4-foot by 6-foot concrete box culvert through the levee, 31.5 feet below the crown. Wood flap gate and concrete headwall on the waterward end. Wooden steps on the landward slope. Concrete steps on the waterward end. Originally included in the O+M Manual. FS Date: 05/11/2015

Flap gates on WS toe.

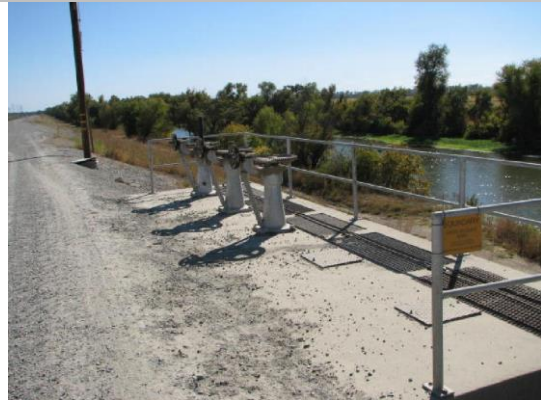
Photo 3 of 3 : UCIP_FA_2015_5217.jpg

Slide gates on WS shoulder.

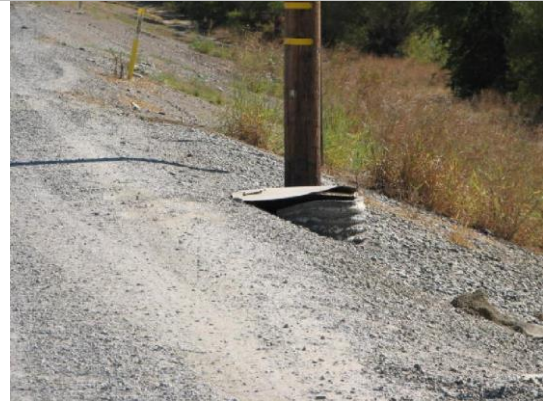
Photo 1 of 1 : UCIP_FA_2015_5218.jpg

LM Start	10.84	Rating **	M	Issue No.	41
LM End	10.84	Issue Type +	En	Location *	WS
Category	Supplemental			GPS Latitude/Longitude	
				Start	End
Item	DWR UCIP Field Study			39.025560 °	39.025560 °
				-121.726846 °	-121.726846 °
DWR ID					
Action/Comments					
Inspector Comments: FS_ID:45089					
DS_ID:16872					
EP_NO: 3165					
FS_HLM: 11.009					
Repair Type: Non-Urgent					
Crossing Status: Found

Siphon breaker in 36-inch CMP riser on WS shoulder. Pipe visible at siphon breaker.

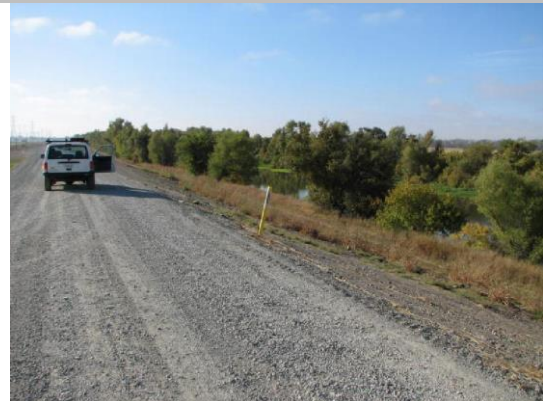
Photo 1 of 2 : UCIP_FA_2015_5219.jpg

LM Start	10.85	Rating **	M	Issue No.	42
LM End	10.85	Issue Type +	En	Location *	WS
Category	Supplemental			GPS Latitude/Longitude	
				Start	End
Item	DWR UCIP Field Study			39.025310 °	39.025310 °
				-121.726770 °	-121.726770 °
DWR ID					
Action/Comments					
Inspector Comments: FS_ID:45090 DS_ID:19986 EP_NO: N/A FS_HLM: 11.027 Repair Type: Non-Urgent Crossing Status: Indicator Found UCIP Comments: 5/7/2015 Crossing is in good condition. No noticeable issues to report.No permit identified for crossing.5/22/2013 Same as last inspection.10/30/2013 Same as last inspection.5/13/2014 Same as last inspection.11/12/2014 Same as last inspection. FIELD_STRUCT_DESC: Gas-line crosses levee at unknown depth. Carsonite sign on both LS and WS shoulder. Owned by Calpine Pipeline Company FS Date: 05/11/2015

Gasline marker on WS shoulder.

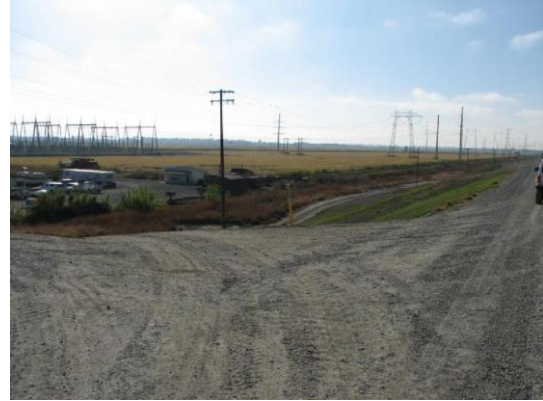
Photo 2 of 2 : UCIP_FA_2015_5220.jpg

LM Start	10.85	Rating **	M	Issue No.	42 (cont)
LM End	10.85	Issue Type +	En	Location *	WS
Category	Supplemental			GPS Latitude/Longitude	
				Start	End
Item	DWR UCIP Field Study			39.025310 °	39.025310 °
				-121.726770 °	-121.726770 °
DWR ID					
Action/Comments					
Inspector Comments: FS_ID:45090 DS_ID:19986 EP_NO: N/A FS_HLM: 11.027 Repair Type: Non-Urgent Crossing Status: Indicator Found UCIP Comments: 5/7/2015 Crossing is in good condition. No noticeable issues to report.No permit identified for crossing.5/22/2013 Same as last inspection.10/30/2013 Same as last inspection.5/13/2014 Same as last inspection.11/12/2014 Same as last inspection. FIELD_STRUCT_DESC: Gas-line crosses levee at unknown depth. Carsonite sign on both LS and WS shoulder. Owned by Calpine Pipeline Company FS Date: 05/11/2015

Gasline marker on LS shoulder.

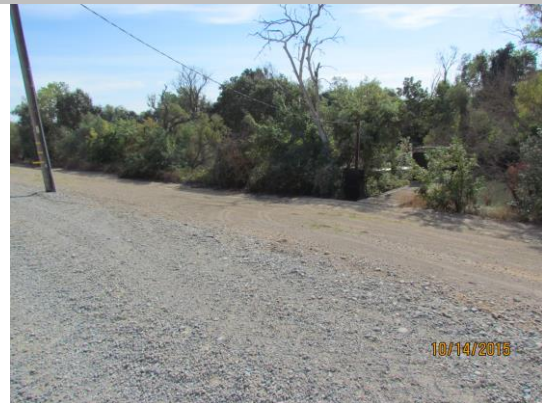
Photo 1 of 1 : FA_2015_ST0002_450_23_20151016_00008.jpg

View of the vehicle erosion along the slope.

Action/Comments					
Repair the levee slope damaged by vehicle traffic and prevent access where possible. Inspector Comments: Repair the erosion along the waterside slope.

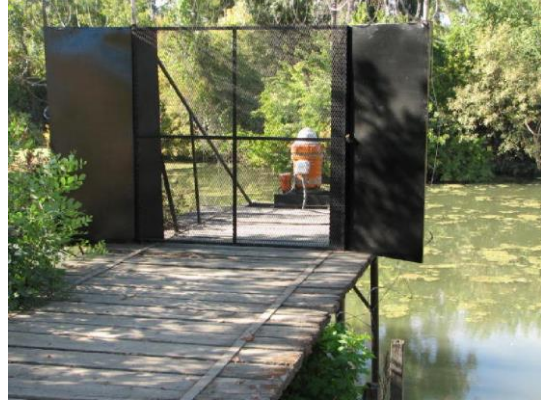
Photo 1 of 3 : UCIP_FA_2015_4740.jpg

LM Start	13.35	Rating **	M	Issue No.	44
LM End	13.35	Issue Type +	En	Location *	WS
Category	Supplemental			GPS Latitude/Longitude	
				Start	End
Item	DWR UCIP Field Study			38.991808 °	38.991808 °
				-121.711512 °	-121.711512 °
DWR ID					
Action/Comments					
Inspector Comments: FS_ID:45103 DS_ID:16873 EP_NO: N/A FS_HLM: 13.539 Repair Type: Non-Urgent Crossing Status: Found UCIP Comments: 5/7/2015 Crossing is in good condition. No noticeable issues to report. Verify work (if any) was done to replace original equipment with inspector. 5/23/2013 Same as last inspection. 10/30/2013 Same as last inspection. 5/14/2014 Same as last inspection. 11/12/2014 Same as last inspection. FIELD_STRUCT_DESC: 18-inch pipe through the levee, 5.5 feet below the crown. Pipe measures 16-inches at pump and on LS outlet. Siphon breaker in a 16-inch corrugated metal pipe riser on the landward slope. Pump on pile structure in the channel. Meter and pole on the bank. Originally included in O+M manual. FS Date: 05/11/2015

Pump on Pier structure on WS toe.

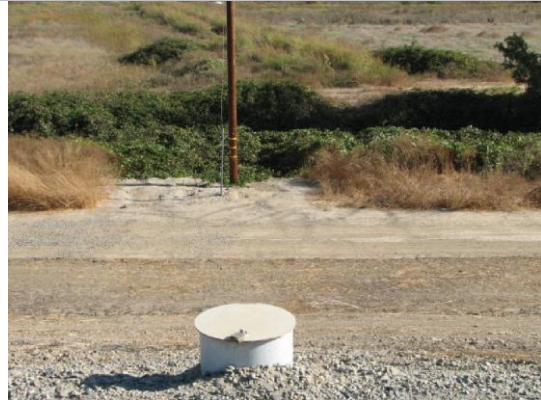
Photo 2 of 3 : UCIP_FA_2015_4741.jpg

Siphon Breaker in 16-inch steel riser on LS shoulder.

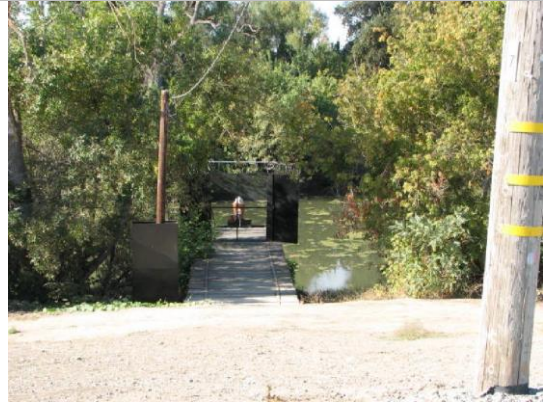
Photo 3 of 3 : UCIP_FA_2015_4742.jpg

LM Start	13.35	Rating **	M	Issue No.	44 (cont)
LM End	13.35	Issue Type +	En	Location *	WS
Category	Supplemental			GPS Latitude/Longitude	
				Start	End
Item	DWR UCIP Field Study			38.991808 °	38.991808 °
				-121.711512 °	-121.711512 °
DWR ID					
Action/Comments					
Inspector Comments: FS_ID:45103 DS_ID:16873 EP_NO: N/A FS_HLM: 13.539 Repair Type: Non-Urgent Crossing Status: Found

Pump on Pier on WS toe.

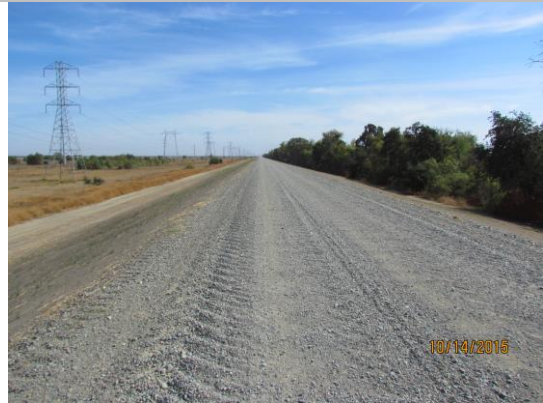
Photo 1 of 1 : FA_2015_ST0002_450_22_20151016_00009.jpg

LM Start	13.57	Rating **	A	Issue No.	22
LM End	13.57	Issue Type +	Ma	Location *	LS
Category	Earthen Levee			GPS Latitude/Longitude	
				Start	End
Item	Vegetation			38.989703 °	38.989703 °
				-121.708392 °	-121.708392 °
DWR ID	DWR_ST0002_01_f_2015_22				
Action/Comments					
Control annual grass and weeds on the levee slopes and easements. Inspector Comments: Sutter Yard burned and dragged the levee slopes.

View of both slopes with no vegetation.

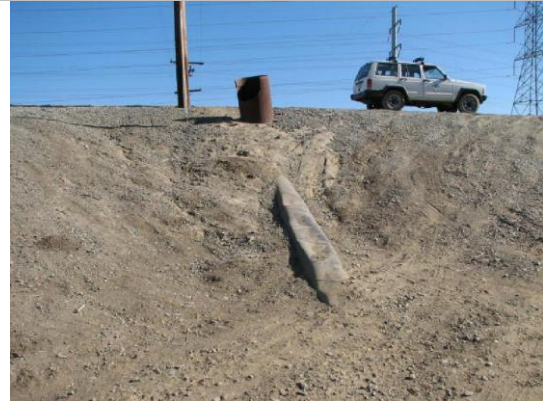
Photo 1 of 3 : UCIP_FA_2015_4743.jpg

Inspector Comments: FS_ID:45105
 DS_ID:16875
 EP_NO: N/A
 FS_HLM: 14.91
 Repair Type: Non-Urgent
 Crossing Status: Found
 UCIP Comments: 5/7/2015 Abandoned crossing. Needs to be properly abandoned. Pipe has not been abandoned properly. It should be removed from the levee section. 5/23/2013 Same as last inspection. 10/30/2013 Same as last inspection. 5/14/2014 Same as last inspection. 11/12/2014 Same as last inspection.
 FIELD_STRUCT_DESC: 16-inch steel pipe through the levee, 3.5 feet below the crown. Siphon breakers in 30-inch steel risers on both WS and LS shoulders. Vertical pump on pile structure in stream (removed).
 FS Date: 05/11/2015

Crushed pipe on WS slope.

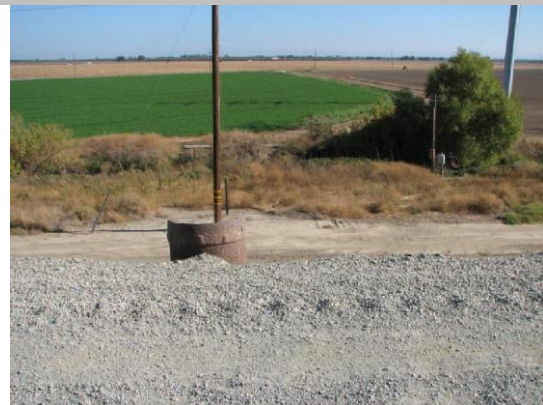
Photo 2 of 3 : UCIP_FA_2015_4744.jpg

Steel riser on LS shoulder.

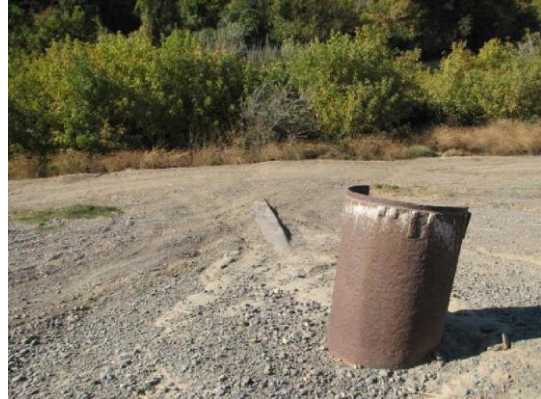
Photo 3 of 3 : UCIP_FA_2015_4745.jpg

LM Start	14.71	Rating **	M	Issue No.	45 (cont)
LM End	14.71	Issue Type +	En	Location *	LS
Category	Supplemental			GPS Latitude/Longitude	
				Start	End
Item	DWR UCIP Field Study			38.979377 °	38.979377 °
				-121.691929 °	-121.691929 °
DWR ID					
Action/Comments					
Inspector Comments: FS_ID:45105 DS_ID:16875 EP_NO: N/A FS_HLM: 14.91 Repair Type: Non-Urgent Crossing Status: Found

Pipe on WS slope exposed and crushed below 30-inch steel riser.

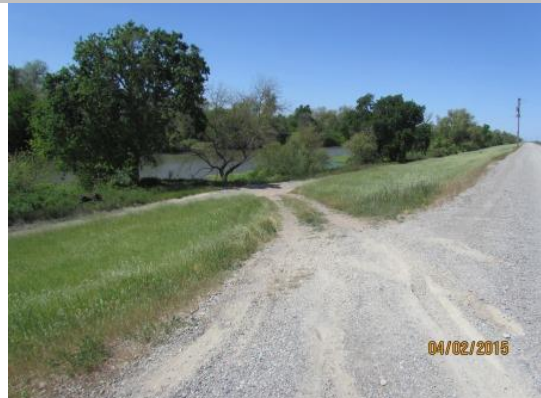
Photo 1 of 2 : FA_2015_ST0002_450_21_20150910_00002.jpg

LM Start	17.60	Rating **	M	Issue No.	21
LM End	17.60	Issue Type +	Ma	Location *	WS
Category	Earthen Levee			GPS Latitude/Longitude	
				Start	End
Item	Slope Stability			38.949965 °	38.949965 °
				-121.653823 °	-121.653823 °
DWR ID	DWR_ST0002_01_s_2015_21				
Action/Comments					
Repair the levee slope damaged by vehicle traffic and prevent access where possible.					
Inspector Comments: Repair the vehicle erosion along the waterside slope.

View of the vehicle erosion along the waterside slope.

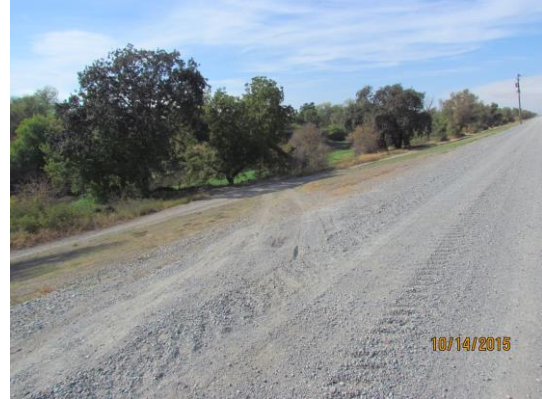
Photo 2 of 2 : FA_2015_ST0002_450_21_20151016_00011.jpg

View of the vehicle erosion along the waterside slope.

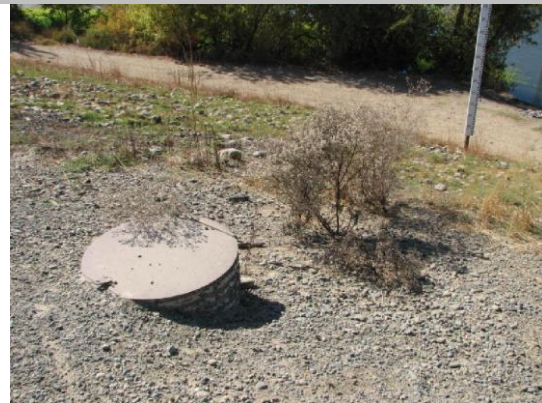
Photo 1 of 1 : UCIP_FA_2015_4777.jpg

LM Start	19.18	Rating **	M	Issue No.	46
LM End	19.18	Issue Type +	En	Location *	WS
Category	Supplemental			GPS Latitude/Longitude	
				Start	End
Item	DWR UCIP Field Study			38.932423 °	38.932423
				-121.635085 °	-121.635085
DWR ID					
Action/Comments					
Inspector Comments: FS_ID:45117 DS_ID:16878 EP_NO: 3165 FS_HLM: 19.461 Repair Type: Non-Urgent Crossing Status: Found UCIP Comments: 5/7/2015 Abandoned crossing. No noticeable issues to report.Need to determine type of abandonment.5/23/2013 Same as last inspection.10/30/2013 Same as last inspection.5/14/2014 Same as last inspection.11/12/2014 Same as last inspection. FIELD_STRUCT_DESC: 10-inch drainage pipe through the levee, 4.0 feet below the crown. Siphon breaker in 36-inch corrugated metal pipe riser on the waterward shoulder. Flap gate on the waterward end. (App. 3165 - DWR) FS Date: 05/11/2015

36-inch CMP riser on WS shoulder.

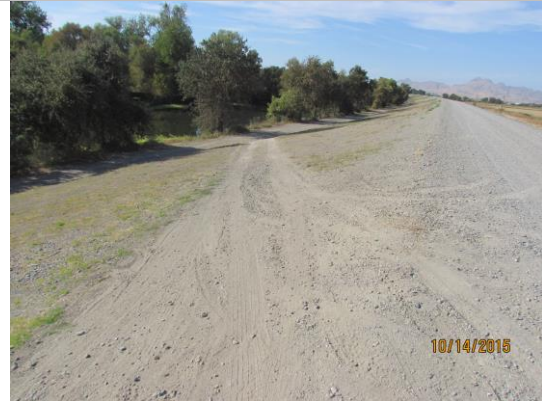
Photo 1 of 1 : FA_2015_ST0002_450_29_20151016_00012.jpg

View of the vehicle erosion along the waterside slope.

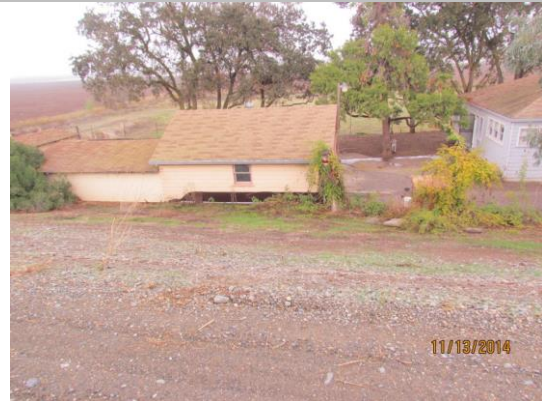
Photo 1 of 1 : FA_2015_ST0002_450_10_20150910_00001.jpg

LM Start	20.34	Rating **	U	Issue No.	10
LM End	20.34	Issue Type +	En	Location *	LS
Category	Earthen Levee			GPS Latitude/Longitude	
				Start	End
Item	Encroachments			38.918147 °	38.918147 °
				-121.624545 °	-121.624545 °
DWR ID	DWR_ST0002_01_s_2012_10				
Action/Comments					
Building

View of the house next to the toe of the levee.
